DEPARTMENT OF TRANSPORTATION

Quality Assurance and Source Inspection

Contract #: 04-0120F4Cty: SF/ALA Rte: 80 PM: 13.2/13.9File #: 69.28**WELDING INSPECTION REPORT****Resident Engineer:**Pursell, Gary**Address:** 333 Burma Road**City:** Oakland, CA 94607**Report No:** WIR-015345**Date Inspected:** 04-Jul-2010**Project Name:** SAS Superstructure**OSM Arrival Time:** 700**Prime Contractor:** American Bridge/Fluor Enterprises, a JV**OSM Departure Time:** 1900**Contractor:** Zhenhua Port Machinery Company, Ltd (ZPMC), Changxing Island **Location:** Shanghai,China**CWI Name:** Mr.Xu Tao/Wu shi guo**CWI Present:** Yes No**Inspected CWI report:** Yes No N/A**Rod Oven in Use:** Yes No N/A**Electrode to specification:** Yes No N/A**Weld Procedures Followed:** Yes No N/A**Qualified Welders:** Yes No N/A**Verified Joint Fit-up:** Yes No N/A**Approved Drawings:** Yes No N/A**Approved WPS:** Yes No N/A**Delayed / Cancelled:** Yes No N/A**Bridge No:** 34-0006**Component:** OBG**Summary of Items Observed:**

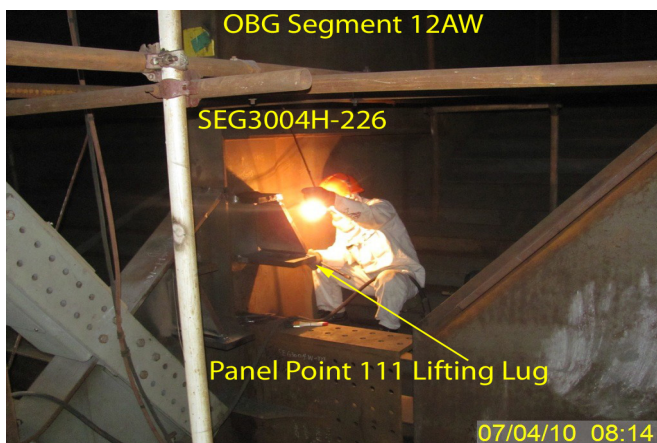
FCAW in the 2G position for the OBG Segment 12AW, weld No: SEG3004H-226. The welder is identified as #201215. ZPMC QC is identified as Mr.Tang ya jun. The welding variables recorded by QC appear to comply with WPS-B-T-2232-TC-U4b-F. Please see the attached picture.

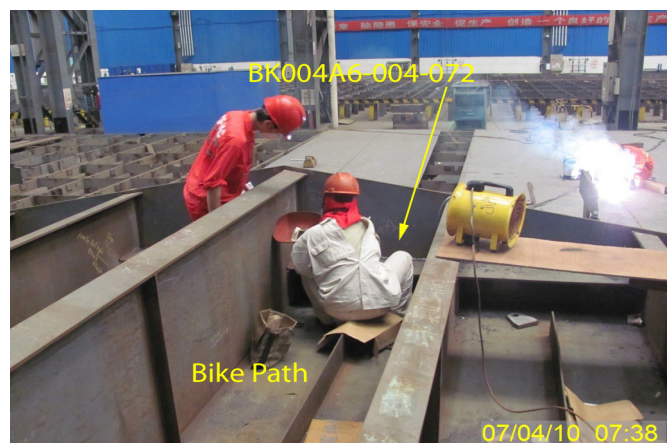
FCAW in the 2F position for the Bike Path, weld No. BK004A6-004-072. The welder is identified as #208641. ZPMC CWI is identified as Mr. Xu Tao. The welding variables recorded by QC appear to comply with WPS-B-T-2132. Please see the attached picture.
